**IOWA STATE PATROL
TECHNICAL COLLISION INVESTIGATION**

ISP Case 2013031880 TI FILE 13-056

SUBJECT: Three Vehicle Collision, Single Fatality

LOCATION: 156 mile marker westbound on Interstate 80, Jasper County, Iowa

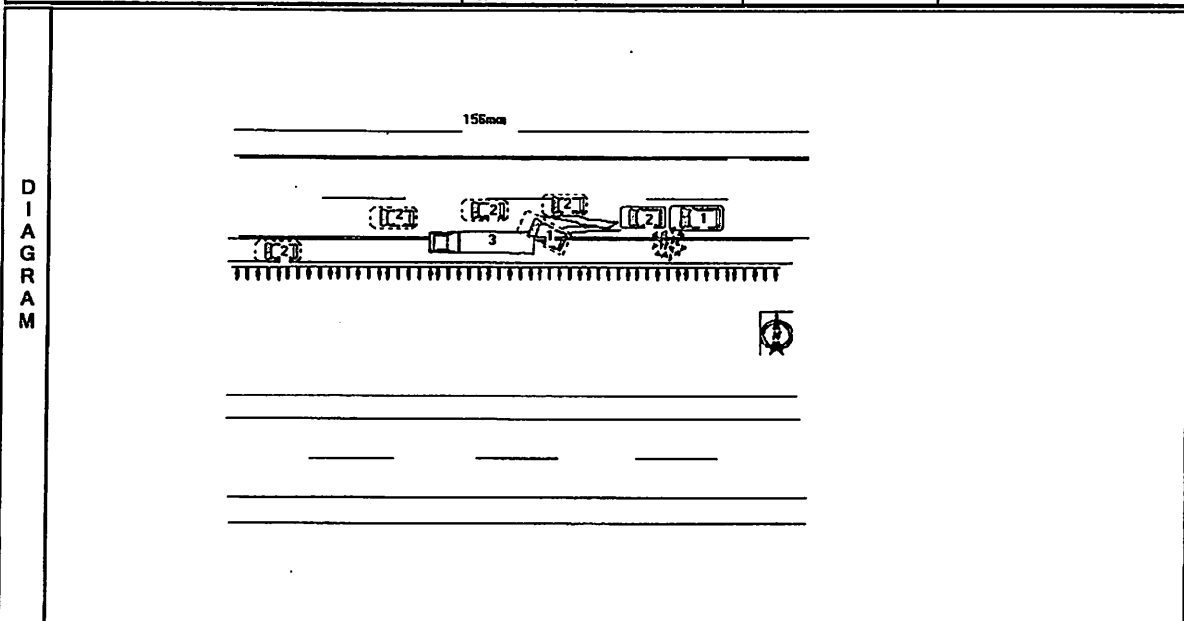
NARRATIVE	
Describe what happened (refer to vehicles by number)	
<p>Unit #1 was traveling west bound on Interstate 80 at approximately the 156 mile marker. Unit #1 collided with Unit #2 in the rear end, send Unit #2 around Unit #3. Unit #3 was parked on the shoulder and the roadway, in the inside shoulder (left lane/fast lane). When Unit #1 collided with Unit #2, Unit #1 went into the rear end of Unit #3 that was parked.</p> <p>The driver of Unit #3 was outside the vehicle looking at the vehicle. The driver of Unit #2 was unharmed and also the passenger. The driver of Unit #1 was fatally injured at the time of the collision.</p> <p>The reasoning Unit #3 was broke down was do to a piece of tire tread the it hit on the roadway, sending it into a brake air line and braking it. When the air line was broke it lost air pressure and then the brakes started closing making the vehicle come to a rest on the shoulder and roadway.</p>

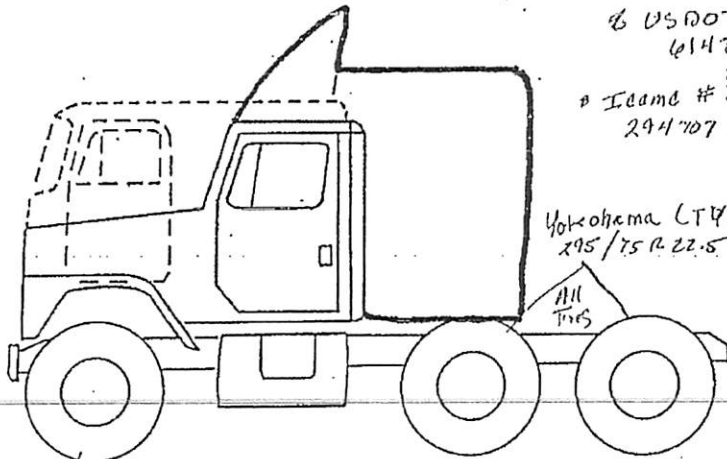
Vehicle No. on Report 3

VEHICLE TYPE		
2011 International T		
REGISTRATION	STATE	YEAR
66AD7D	M	13
SERIAL NO.		
3H5ATAPROBN267185		
COLOR	ODOMETER	
BLUE
